## Vibration Stress Testing Report

This report presents the results of a systematic stress test conducted on standard Luxonis devices. The purpose of this test was to assess the performance parameters of focus, stereo depth, and camera angles under controlled conditions before and after conducting the vibration test according to **EN 60068-2-6:2008** standard.

Tests were conducted on three cameras, OAK-D-PoE, OAK-D-Pro-PoE and OAK-D-Pro.

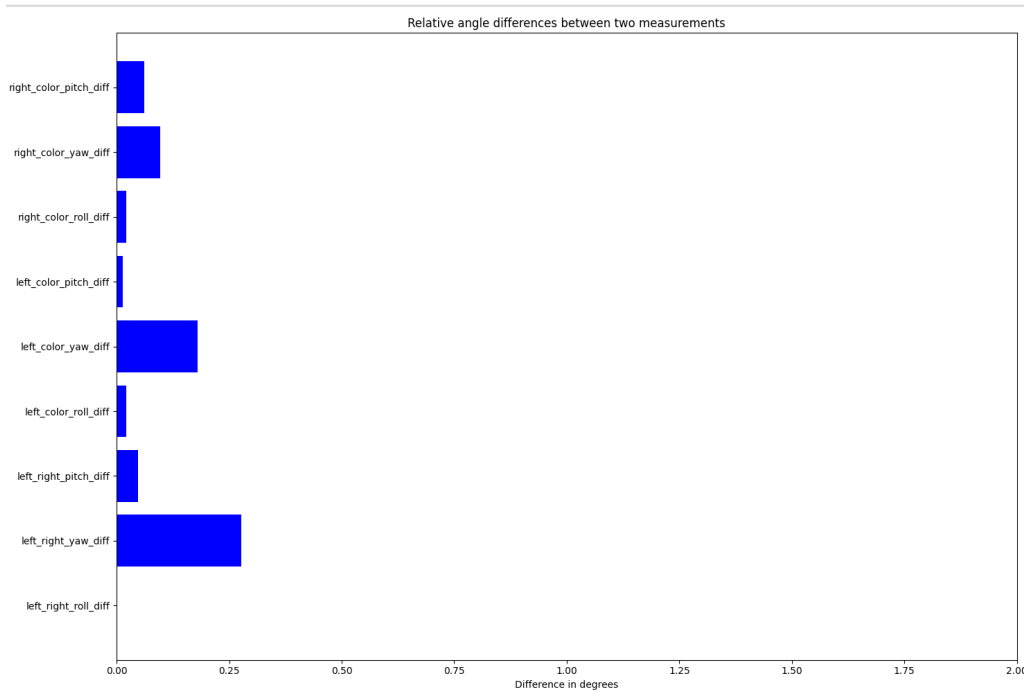
## OAK-D-PoE

In successive tests, all three cameras showed differences that were as low as when comparing a single unit twice with no tests being run in between. This suggests that the sensors did not undergo significant movement relative to each other within the detectable limits of the test.

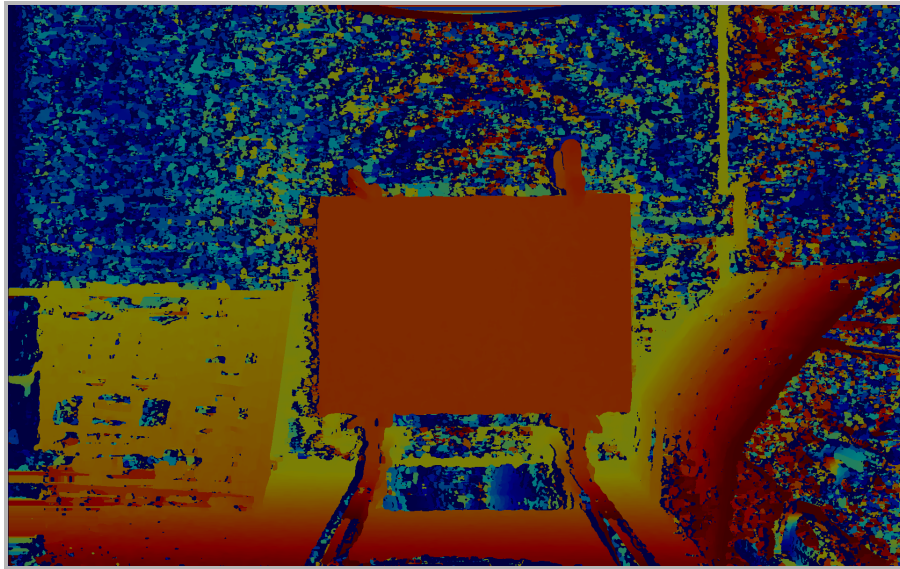
Depth before vibration testing

Z accuracy: **-1.37%** of GT (avg distance: 986.19mm)

Spatial noise: 13.86 mm

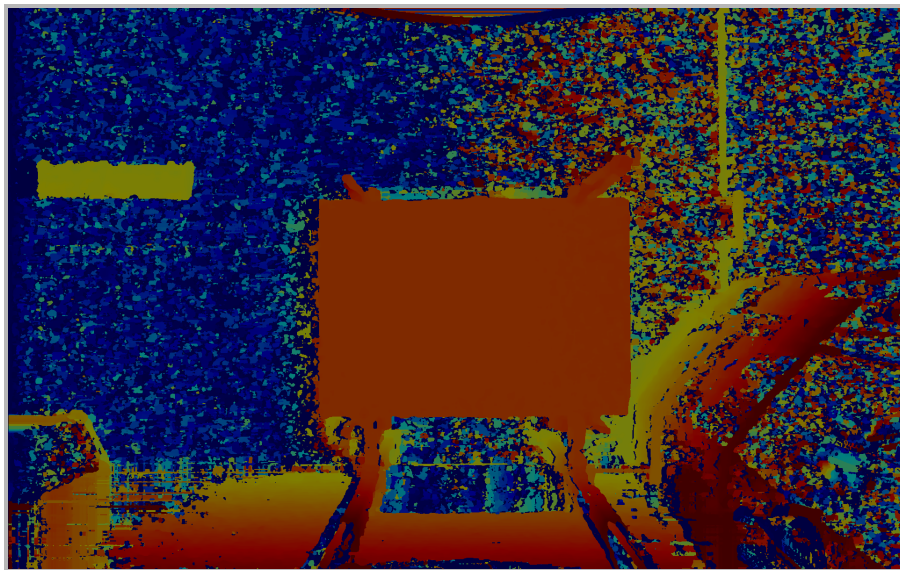
Depth after vibration testing

Z accuracy: **-1.45%** of GT (avg distance: 984.52mm)

Spatial noise: 15.74 mm

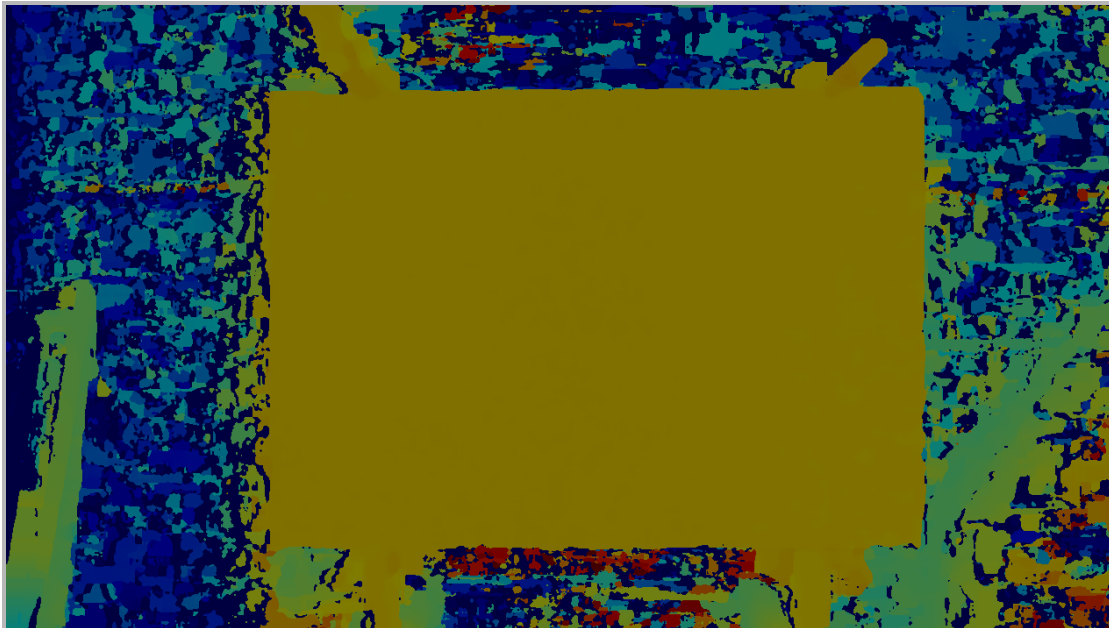
Depth before vibration testing

Z accuracy: 4.06% of GT (avg distance: 1041.72mm)

Spatial noise: 41.71 mm

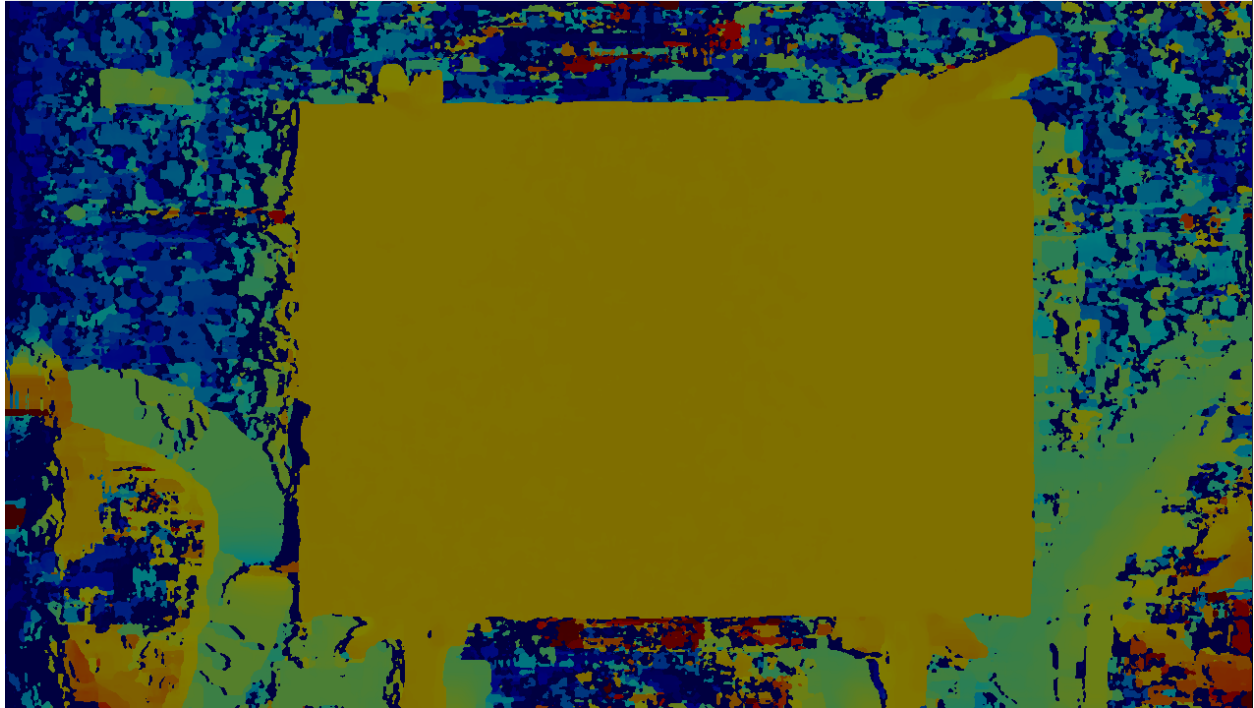
Depth after vibration testing

Z accuracy: 4.06% of GT (avg distance: 1040.17mm)

Spatial noise: 40.19 mm
