# Test report

**Number** T211-0577/23

**Product:** Camera

**Type reference:** OAK-D-Pro-PoE

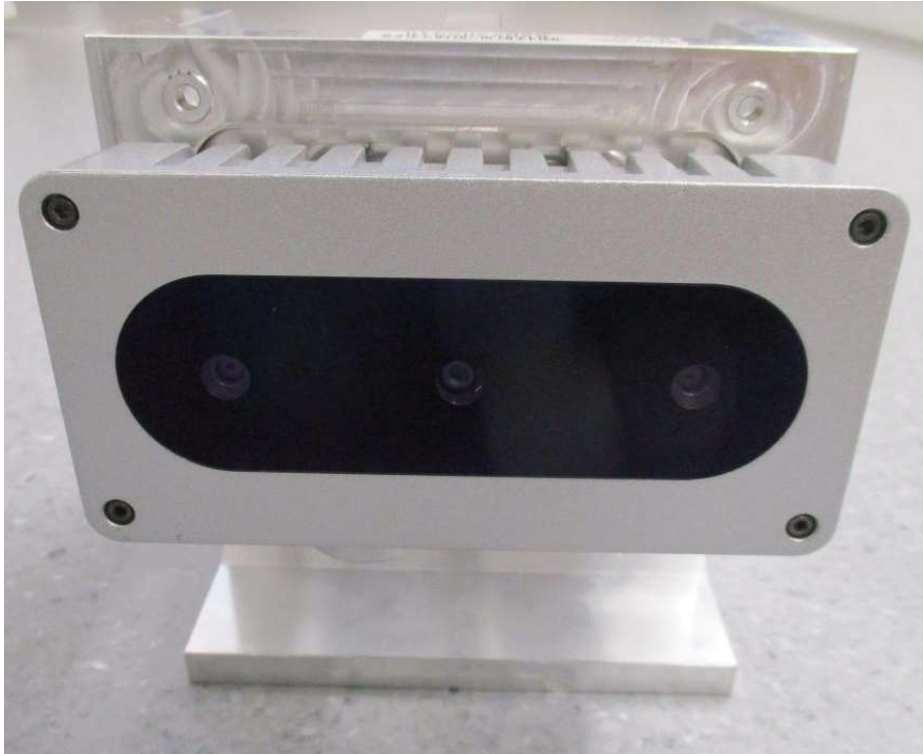
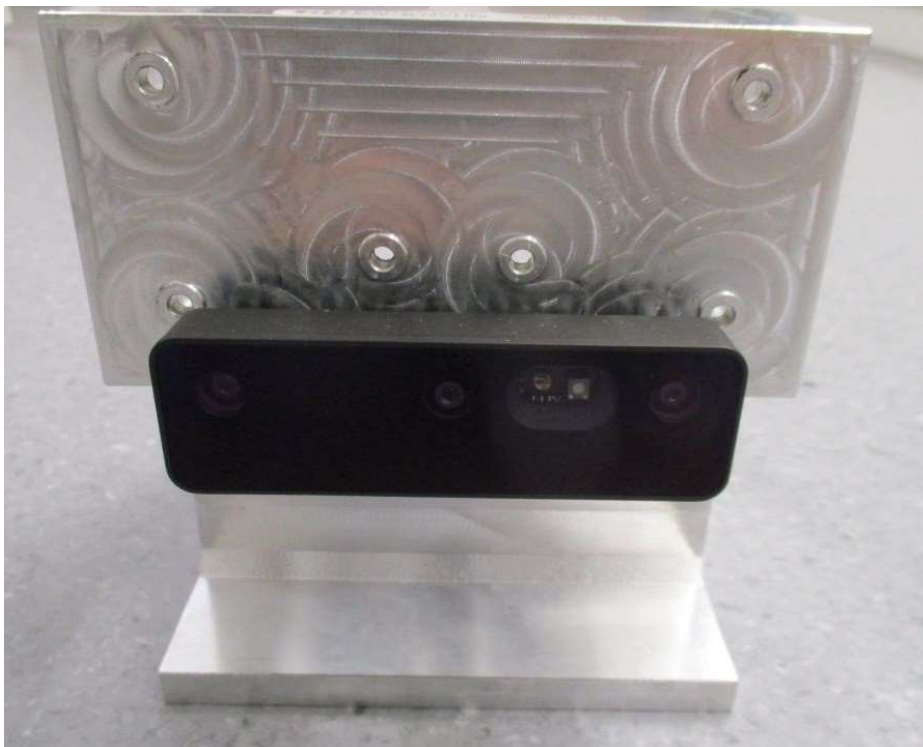
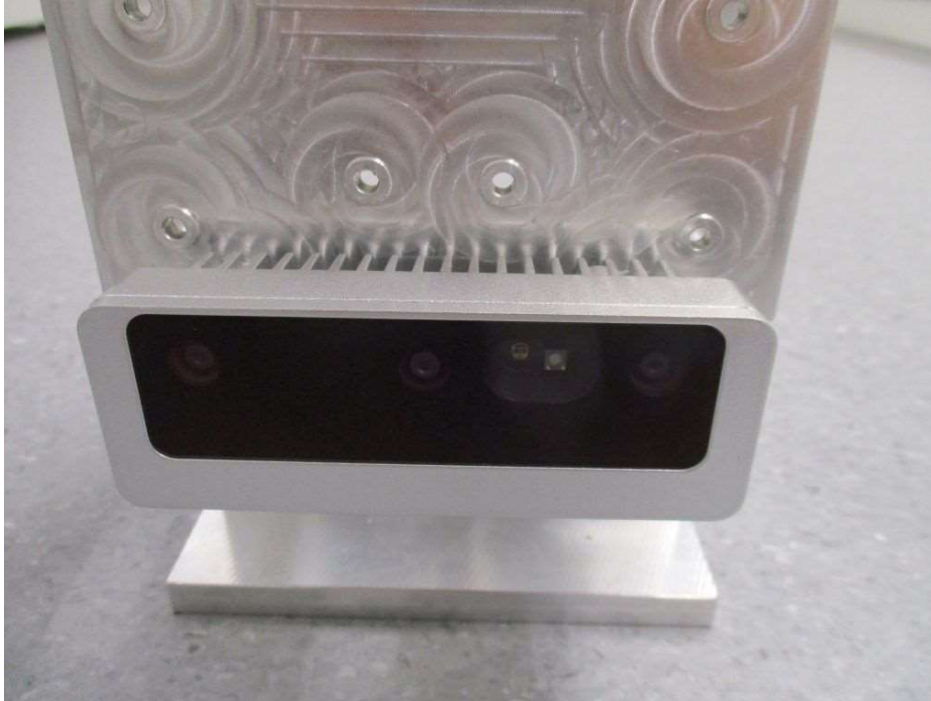
Five cameras, see Figures 1 to 5 were subjected to vibration test according to standards EN 60068-2-6:2008 and ISO 15998:2008 Clause 7.2.3 Table 1. During the tests, the samples were not operating. The aim of the test was to check possible damages after vibration test.

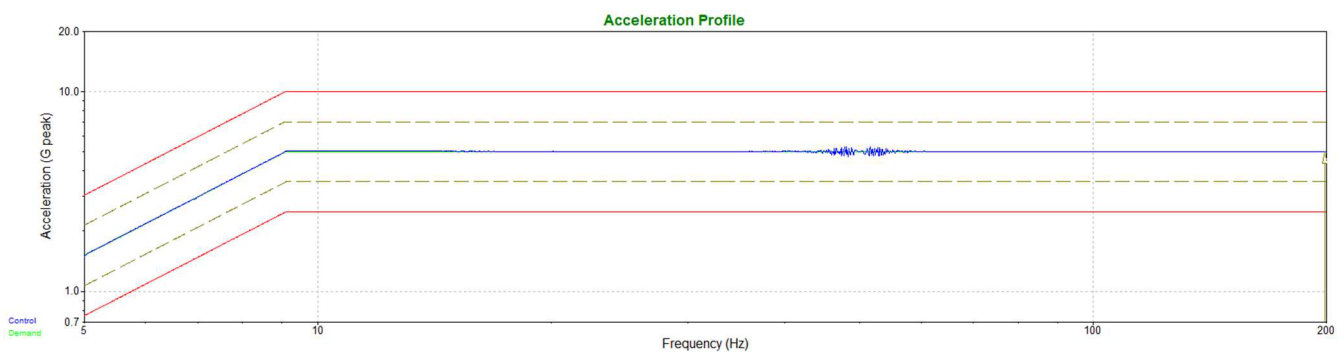
Figure 9

- Environmental temperature 23 °C.
- State of EUT: Not operating.
- Orientation: X, Y, Z-axis.
- Total frequency range: 5 ÷ 200 Hz.
- Frequency range 5 ÷ 9 Hz: Acceleration amplitude: ±15 mm.
- Frequency range 9 ÷ 200 Hz: Acceleration amplitude: 50 m/s<sup>2</sup>.
- Sweep rate: 1 oct/min.
- Duration of the test: 20 sweep cycles per axis.

The sine vibration parameters are shown in Figure 9:
