## Vibration Stress Testing Report

This report presents the results of a systematic stress test conducted on standard Luxonis devices. The purpose of this test was to assess the performance parameters of focus, stereo depth, and camera angles under controlled conditions before and after conducting the vibration test according to **EN 60068-2-6:2008** standard.

Tests were conducted on three cameras, OAK-D-PoE, OAK-D-Pro-PoE and OAK-D-Pro.

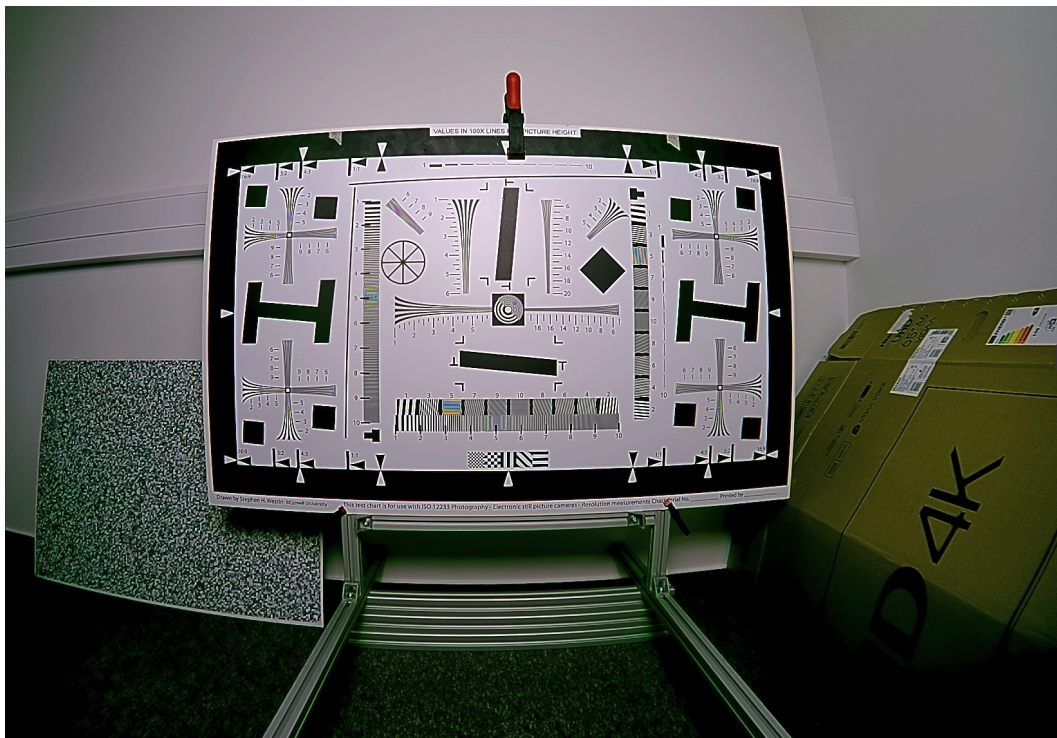
Above is an example picture of the focus board capture.

**No cameras had no visible degradation in the focus of the lenses after being in the vibration chamber.**

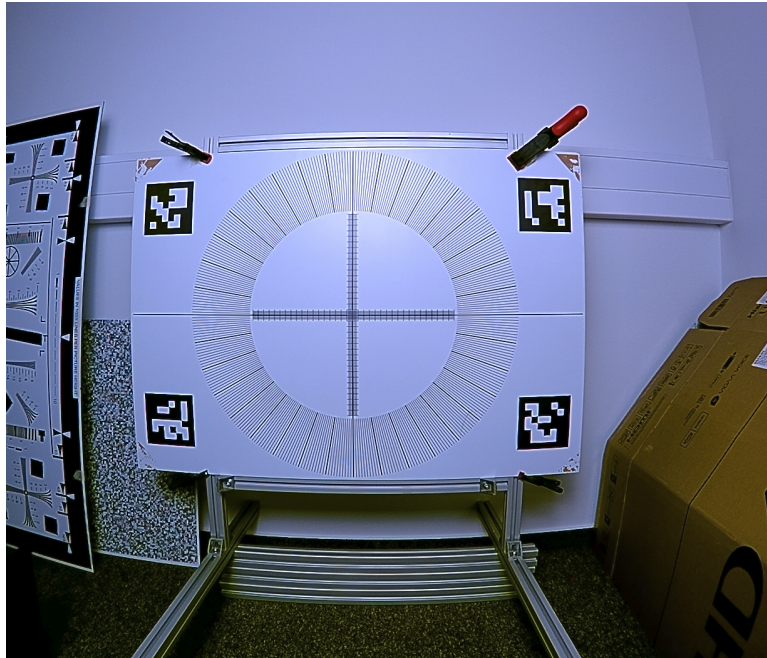
Board used for angle tests.

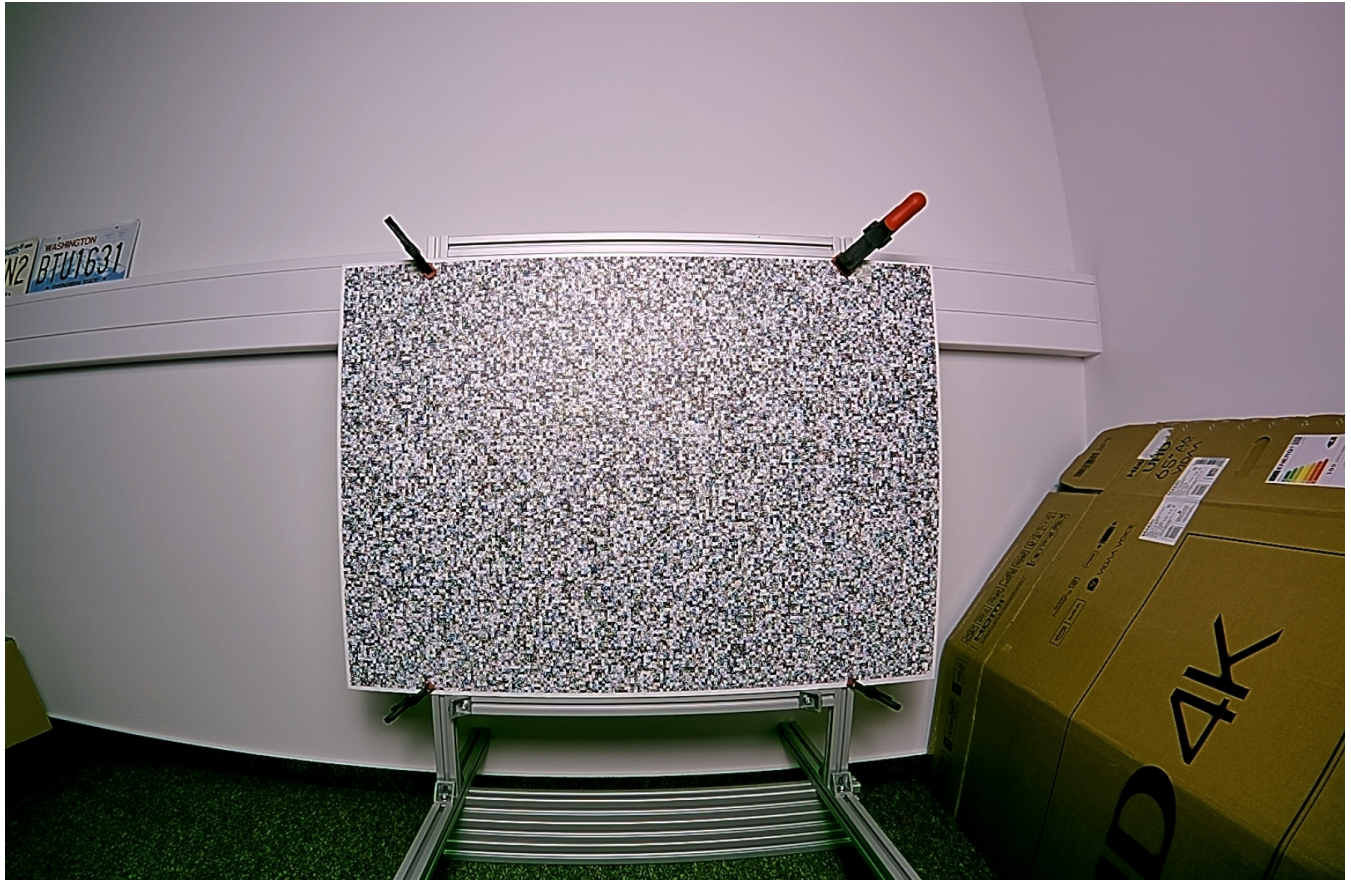
The purpose of depth testing was to check if the depth degraded after the cameras were tested on the vibration desk. It was done on a noise pattern that was mounted in front of the camera .

All cameras have **little to no depth degradation** after being subjected to the vibration tests detectable by our testing method.
